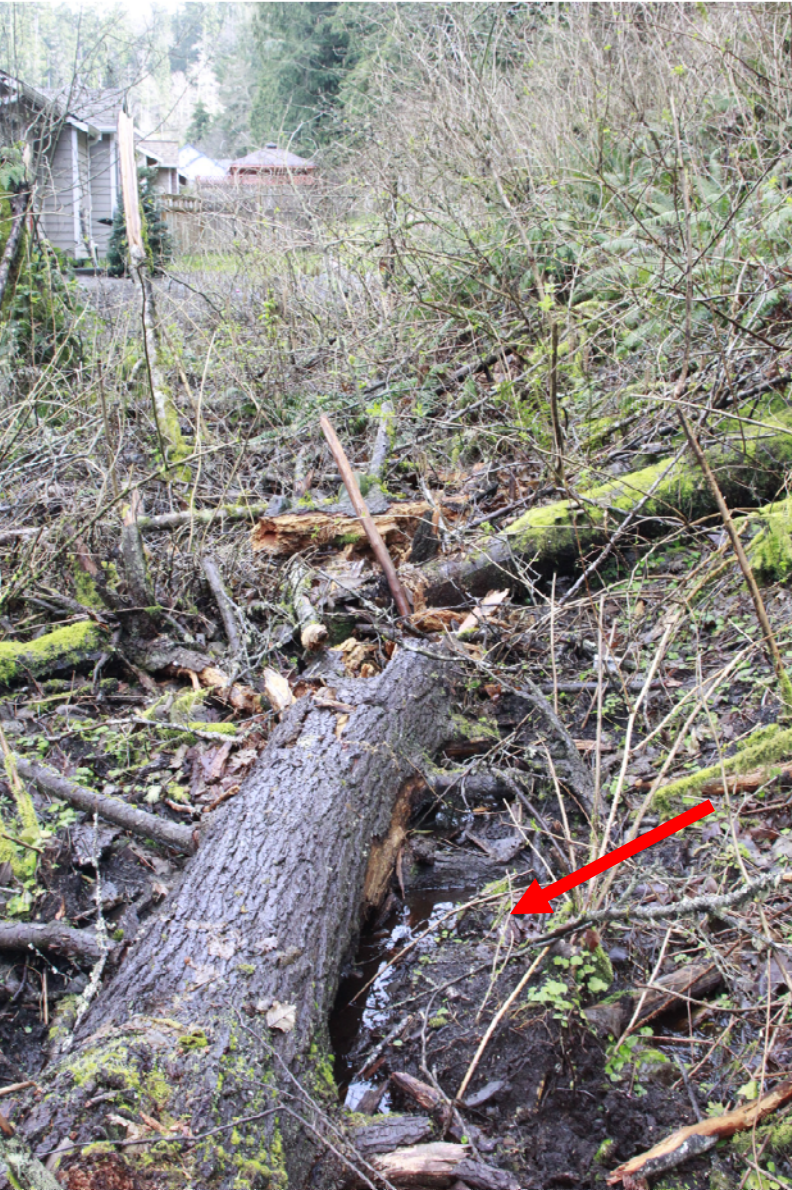
Although the geotechnical reports states that seeps were never observed, I photographed this seep (red arrow) at the toe of the landslide hazard area in the Regatta Estates Tract 992 utility corridor. Homes along 133rd Place W are seen to the east.
